**CITY OF ST. FRANCIS, MN
EXISTING FACILITIES
ASSESSMENT REPORT, STEP TWO
OCTOBER 31, 2018**

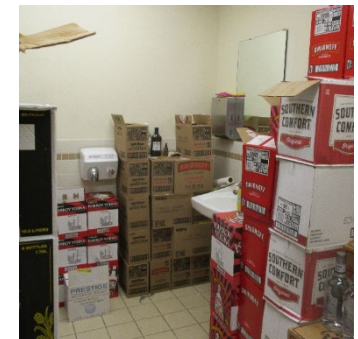
Due to lack of product storage space, the public restrooms and emergency exit hallway are being used for storage. This cuts down on the required widths and accessibility to these spaces, creating code violations. The HC grab bars within each restroom currently do not comply with MN HC Accessibility requirements.

Product storage in restroom

- A building addition for product storage should be added to the east side of the existing Bottle Shop where it will not impede parking count or customer service access.
- Move stored products out of Restrooms and Exit Hall for HC accessibility and sanitation.
- Replace HC grab bars in Restrooms.
- Enhance exterior appearance with additional landscape plantings and shade trees.
- Enhance interior with new finishes; ceramic floor tile, paint walls, replace transaction counter.

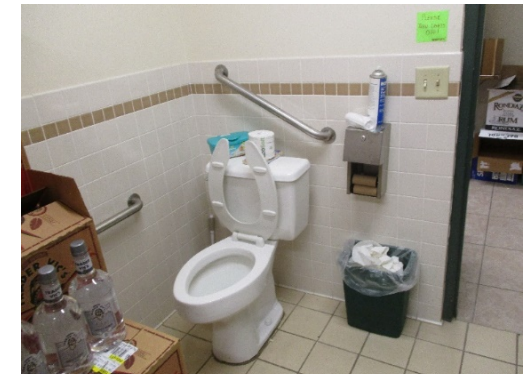
Product storage in restroom and hallway

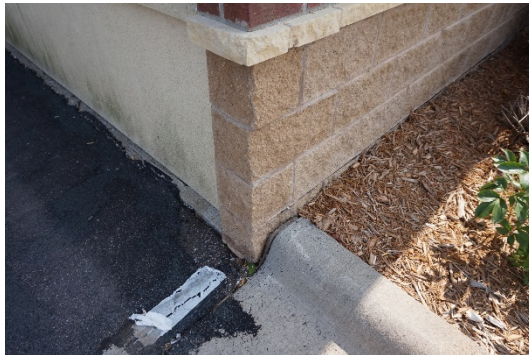
The top of the northwest footing is damaged.

Northwest footing

- Repair the top of the damaged northwest footing.
- Tuckpoint the cracked brick and CMU on the west side; monitor for additional settlement after repair.
- Repair the damaged EIFS on the north and east sides.
- Consider adding gutters and downspouts.

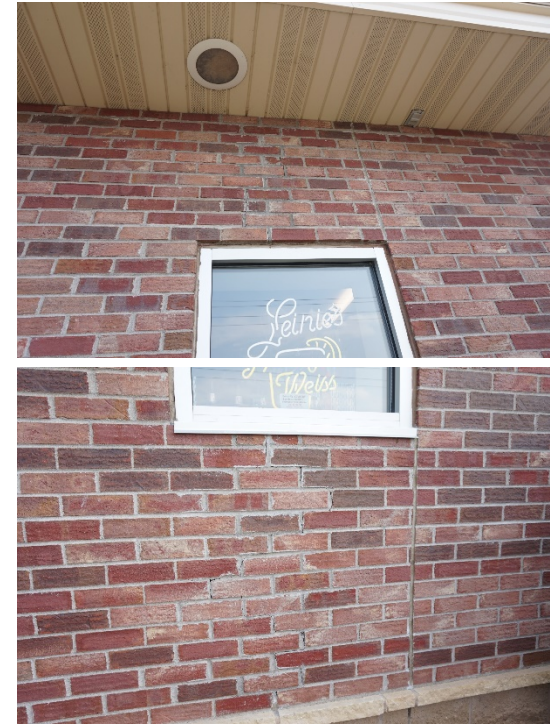
The brick is cracked on the west side due to differential settlement.

Cracking brick and CMU on west side

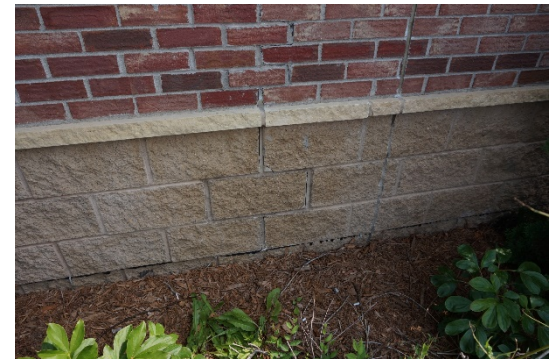
On the north and east exteriors, there are several damaged sections of the EIFS surface that need to be repaired to stop rain water infiltration causing further damage within the walls. (See photos)

The EIFS is damaged on the north and east sides, and there are no gutters on the building.

EIFS damage

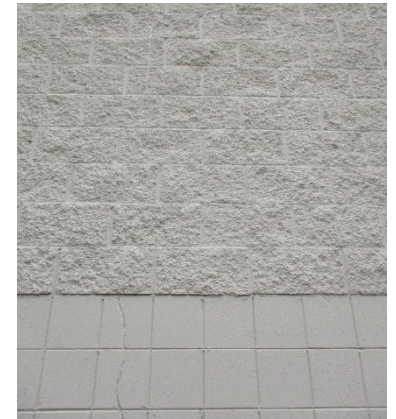
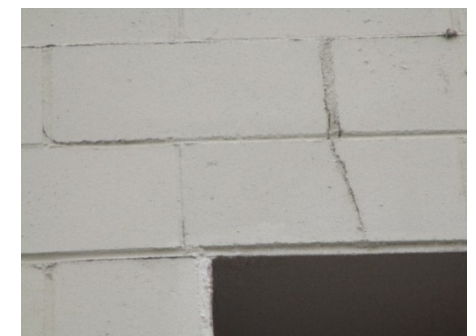
The west and south exterior CMU walls of the Apparatus Bays show numerous vertical cracks, some show through to the inside as well. After further investigation, these cracks do not appear to be caused by structural failure. These appear to be a result of thermal differential movement, caused by extreme temperature differences on the interior versus exterior. These exterior walls are constructed of 12" wide CMU and not insulated, allowing the inside heat to flow outward thru the CMU walls during winter months. Extreme cold surface on the exterior and warm surface on the interior move at different rates. Overall building condition is rated Poor.

CMU cracking

- Apply a water-proof paint coating to the exterior of the Apparatus Bays to stop driven-rain infiltration.
- VCT flooring is old, worn, and stained in numerous locations. Replacement recommended.
- One shower provided in both Men and Women toilet rooms, used by both public and staff
- The drinking fountain is not ADA compliant.
- Urinal in men's room is not ADA compliant.
- Insulate north, west and south walls of Apparatus Bay.
- Insulate south and east exterior walls of the EMT garage.
- Remove/reconstruct Restrooms and Showers adjacent to Apparatus Bays.

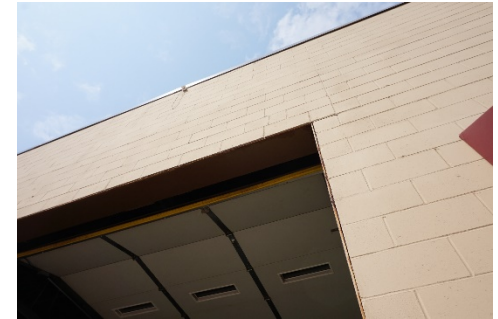
The overhead door lintel plates are rusting. Above an interior door, between the additions, there is exposed CMU block with open cores visible.

Overhead door lintel plate rust

- Remove the rust on the overhead door lintel plates and repaint. Verify that lintel is not rusted through.
- Install lintel above interior door to cover and support the exposed CMU block open cores.

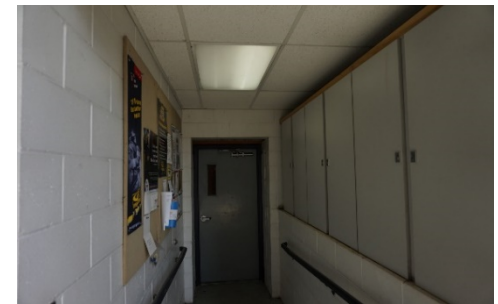
Exposed CMU block

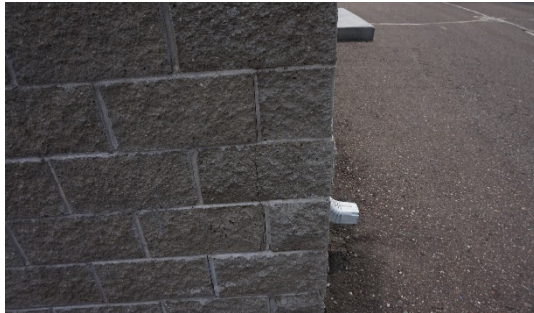
CMU is degraded on the northwest corner and cracked under the east side (center) windows. The west doors do not have lintels.

CMU degradation on northwest corner

- Tuckpoint the cracked CMU mortar joints on the northwest building corner.
- Install double angle lintels over the west doors and tuckpoint the CMU.
- Tuckpoint the cracked CMU mortar joints under the east side windows.

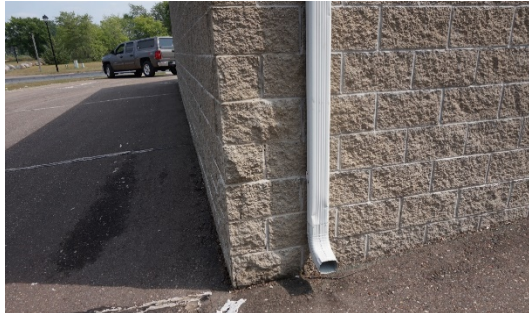
CMU degradation on northwest corner

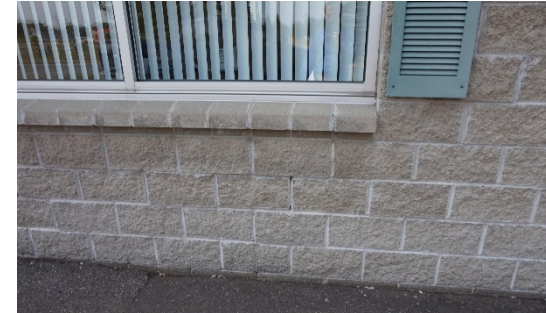
CMU cracked under east window

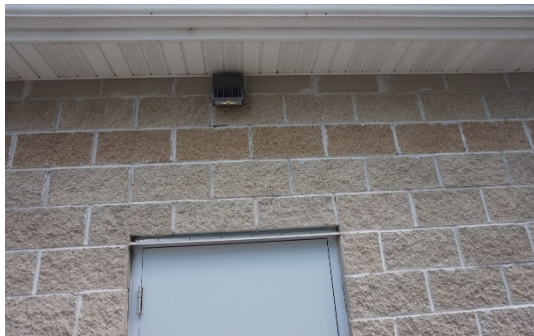
No lintels on west doors (A)

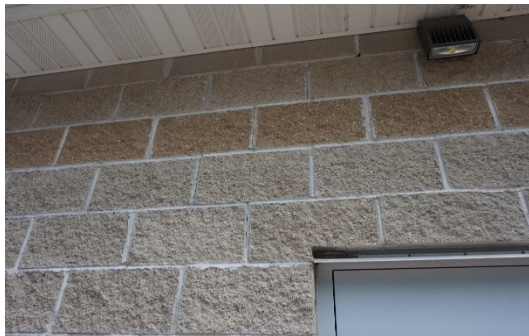
No lintels on west doors (B)

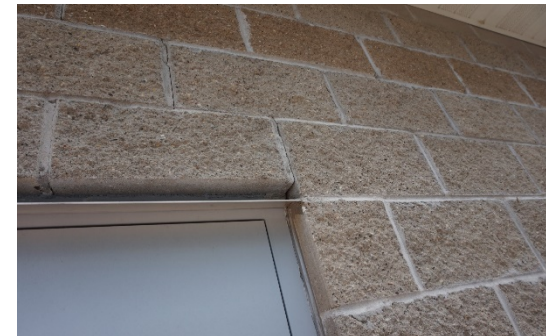
No lintels on west doors (C)

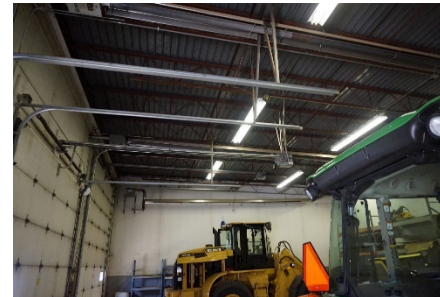
Garage door openers

- › Replace garage door openers.
- › Replace damaged door trim.

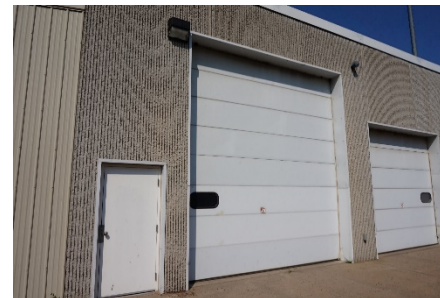
Damaged door trim

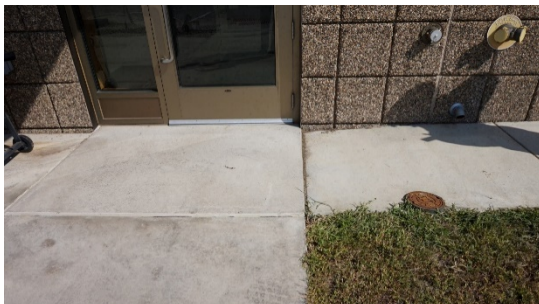
Parts of the sidewalk are heaving, and the bituminous pavement is settling near the stoops. The precast walls are cracked in the upper band, and around the window openings on the exterior wythe. At the public works building, mild salt corrosion is located at the concrete slab joints. At the police station, water is leaking through the overhead door lintel screws, and paint is peeling on the caulk joints in the wash bay.

Heaving sidewalk

- Monitor the sidewalk heaving and bituminous pavement settling to avoid trip hazards and to allow proper opening of the exterior doors. If significant ponding is observed, we would recommend re-grading and repaving these areas.
- Monitor the precast wall cracks in the upper band, and around the window openings on the exterior wythe to ensure that they do not continue to grow. Cleaning and caulking the cracks is recommended to prevent water infiltration.
- Monitor the mild salt corrosion in the concrete slab joints at the public works building. Once the top layer of concrete is corroded, we recommend grinding the surface and coating with epoxy.
- At the police overhead door lintels, install flashing for the full precast wall depth. Remove rust on the lintels before repainting the lintels.
- Repaint the Public Works wash bay walls.

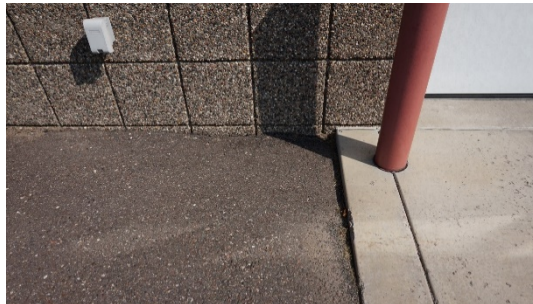
Bituminous settling near stoops

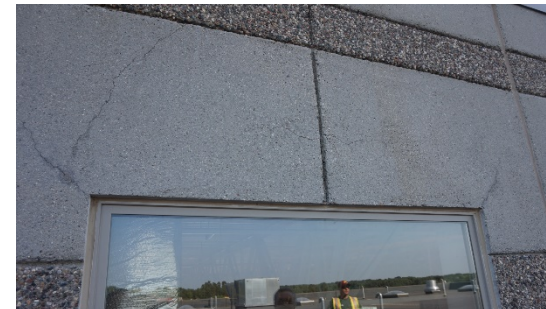
Cracked precast walls

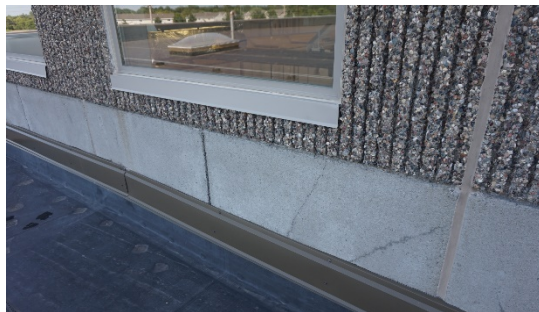
Cracked precast walls

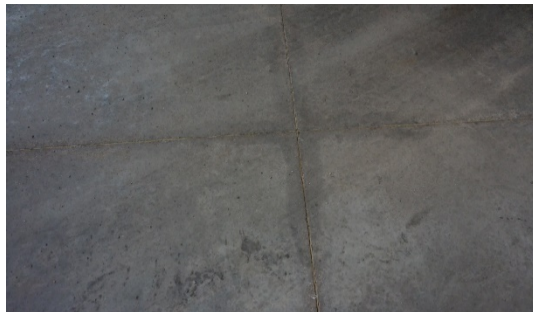
Mild salt corrosion at slab joints of PW Garage

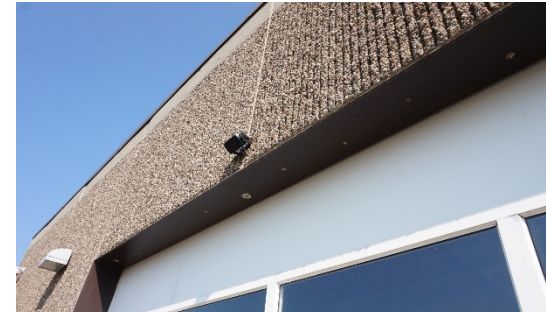
Water leaking through OH door lintel screws

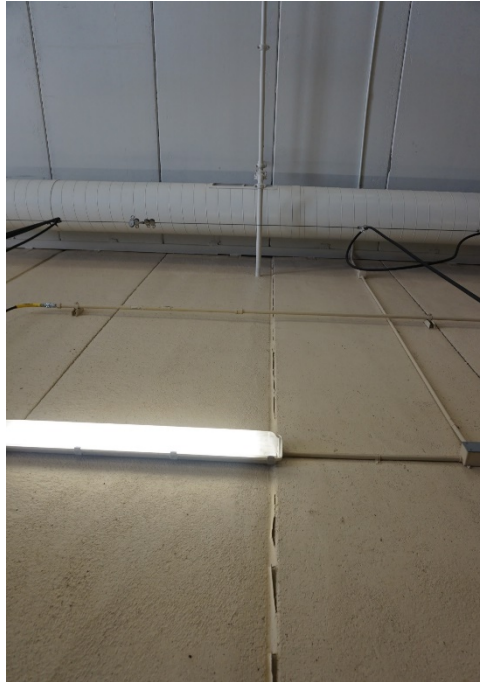
Sealant pulling away at Wash Bay PC joints

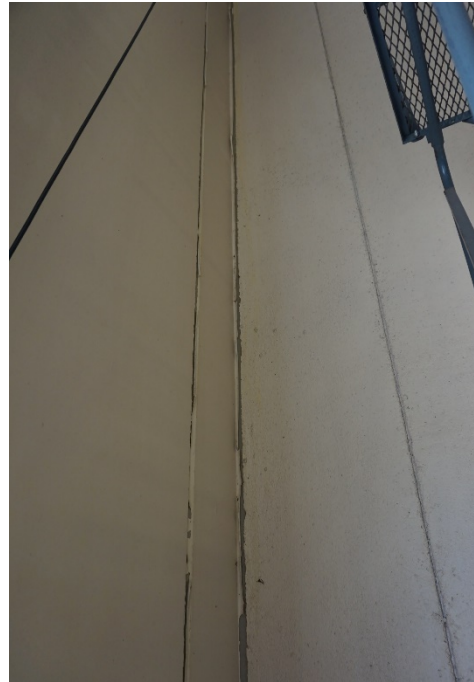
Paint deteriorating at wash bay
