ASBESTOS AND REGULATED WASTE ASSESSMENT

3757 Bridge Street NW
St. Francis, Minnesota

Project # 7207-00

January 12, 2018

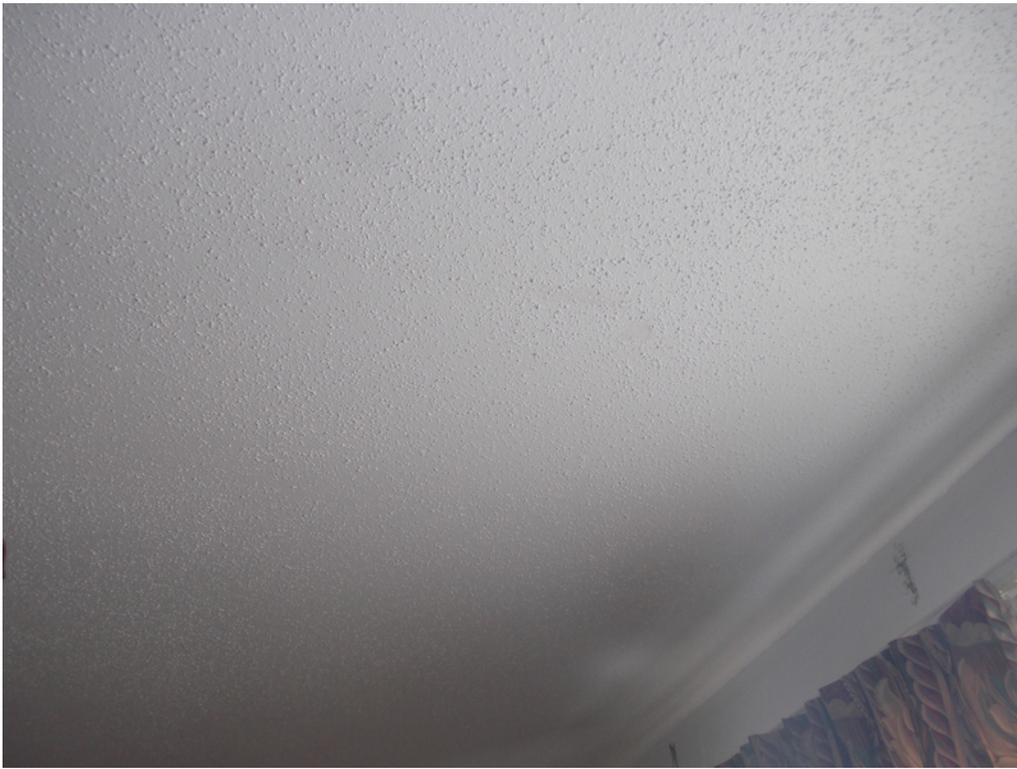
Photograph 1 - View of ceiling texturing, Sample31a.

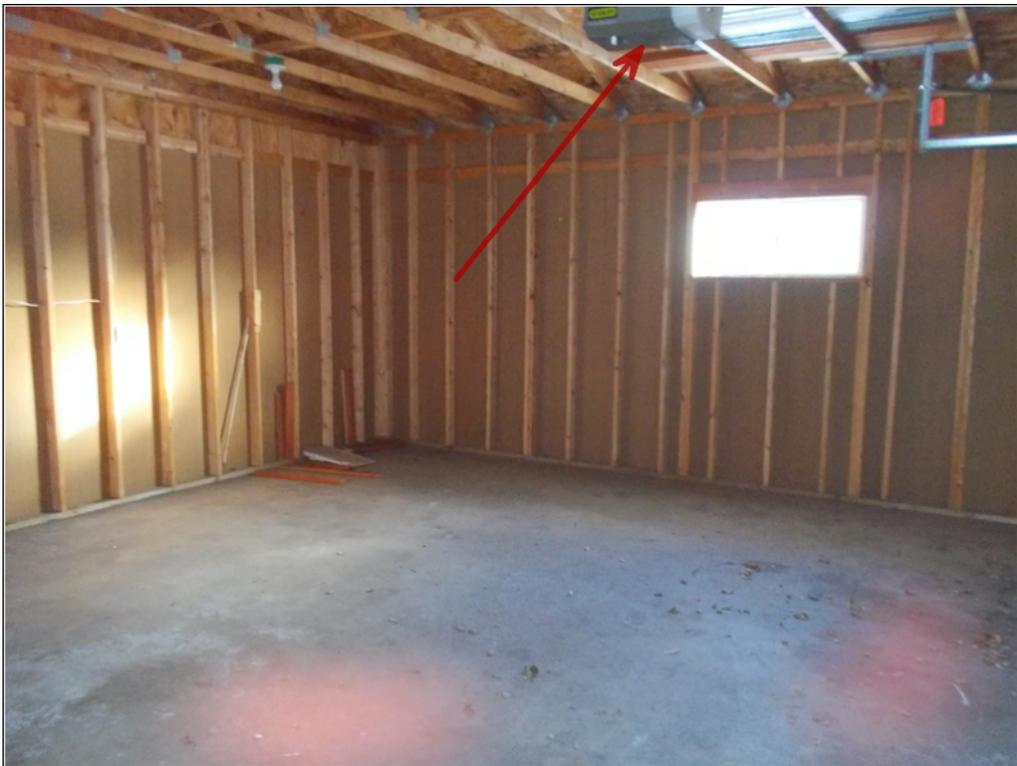
Photograph 2 - View of the interior of the garage and garage door opener motor.

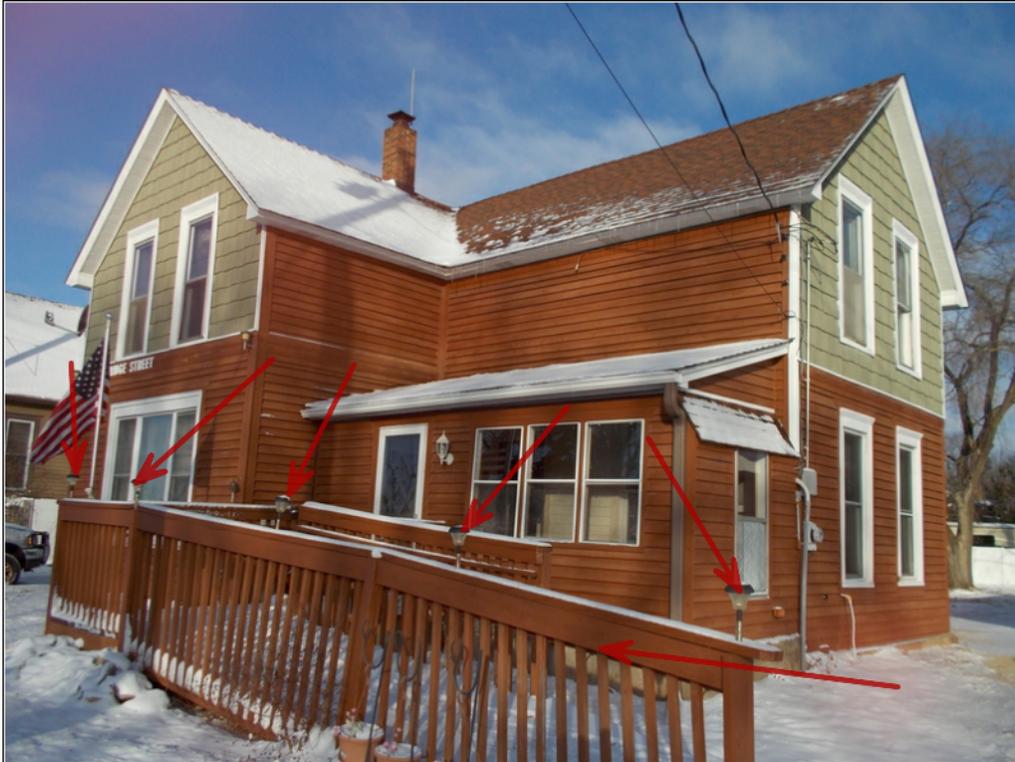
Treated wood was identified on the ramp on the south side of the home. The ramp is approximately 120 square feet

Photograph 6 - View of the south side of the home with the ramp and solar lights.

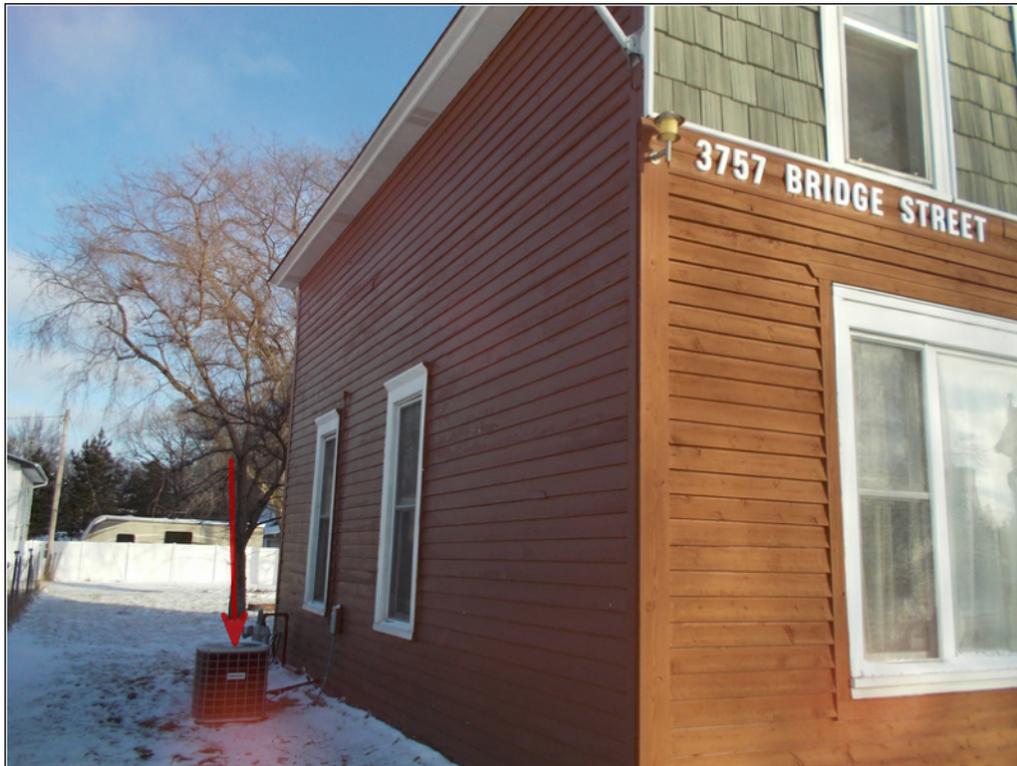
One air conditioner was identified on the west side of the exterior of the home.

Photograph 7 - View of the west side of the home and air conditioner.

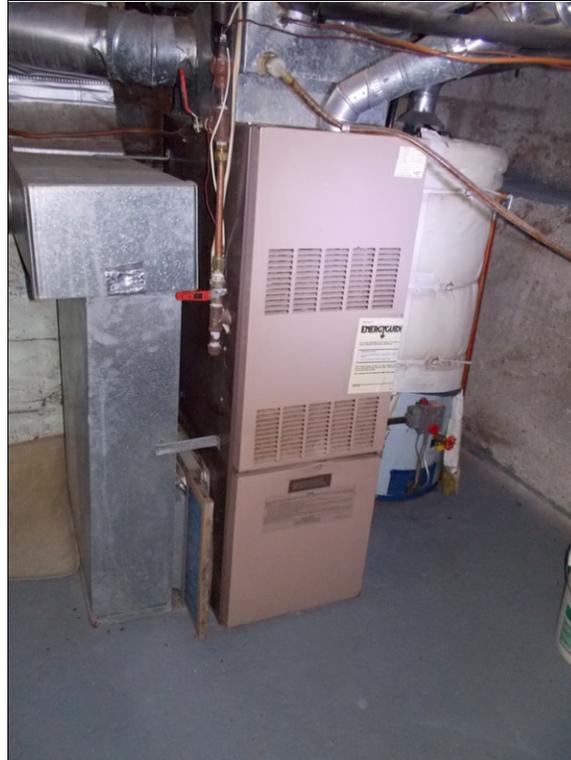
Photograph 8 - View of the furnace and water heater.

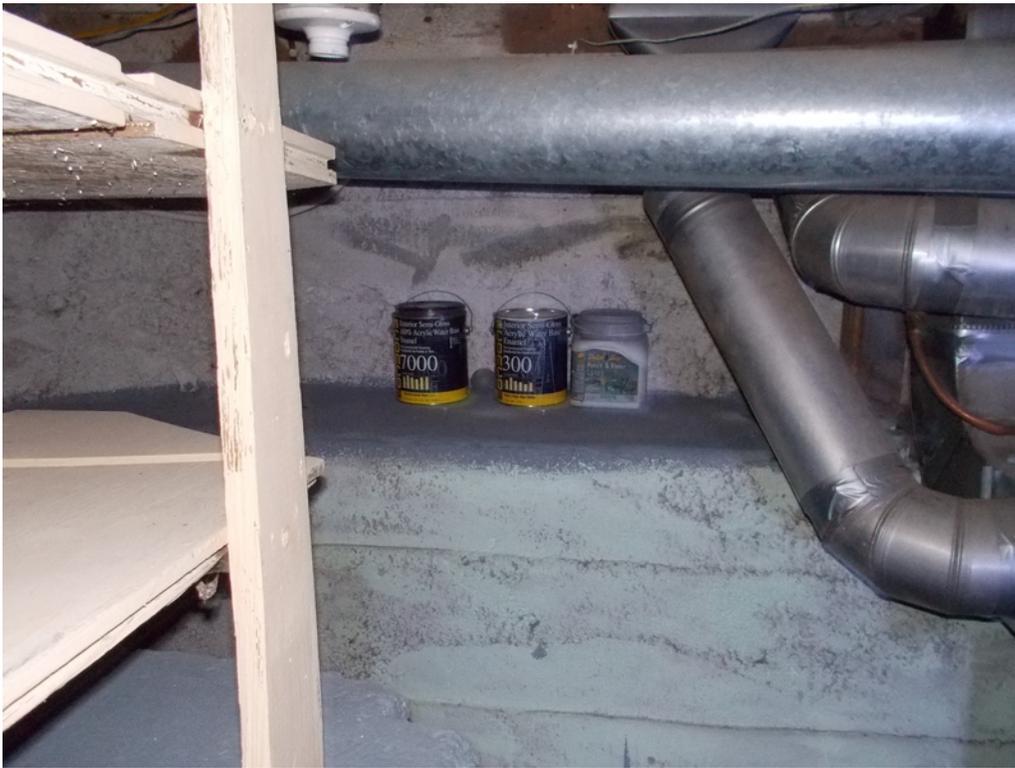
Photograph 9 - View of the paint cans in the basement.

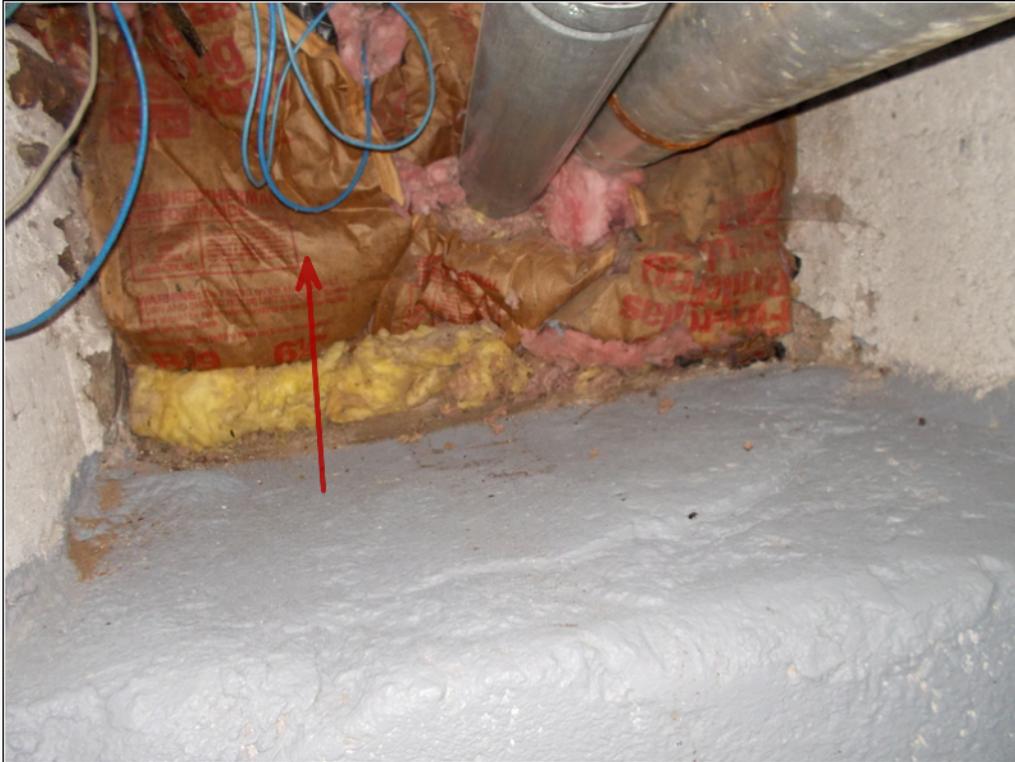
Photograph 10 - View of the fiberglass backing in the basement, Sample 10.

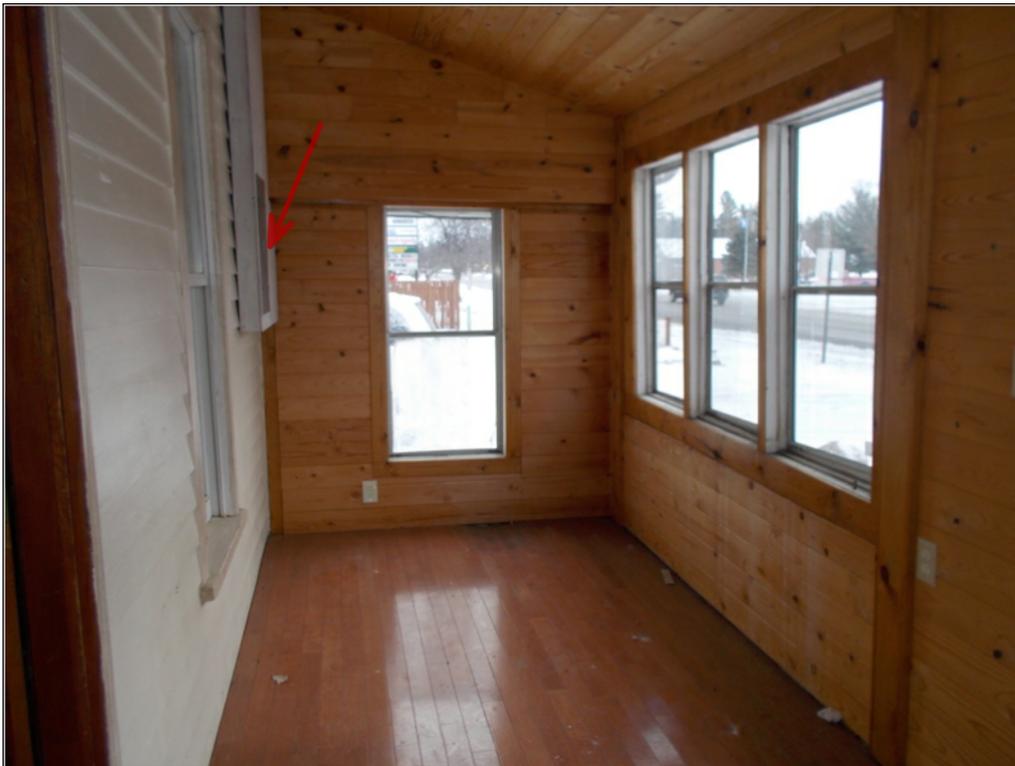
An electrical panel was identified in the porch. Samples were not collected from the panel, but it is assumed that the paper or insulators in this panel contain asbestos. This panel must be removed as asbestos containing material prior to demolition. Also, electrical wiring throughout the buildings was not sampled due to live power; therefore, the wiring is also assumed to contain asbestos.

Location	Sample Description	% Asbestos	Estimated Quantity	Item	Condition	Sample
House porch	Electric panel	Assumed	1	Cat II	Good	not applicable
Throughout	Wiring	Assumed	200 linear feet	Cat. II	Good	not applicable

Photograph 11 - View of the porch and electrical panel.

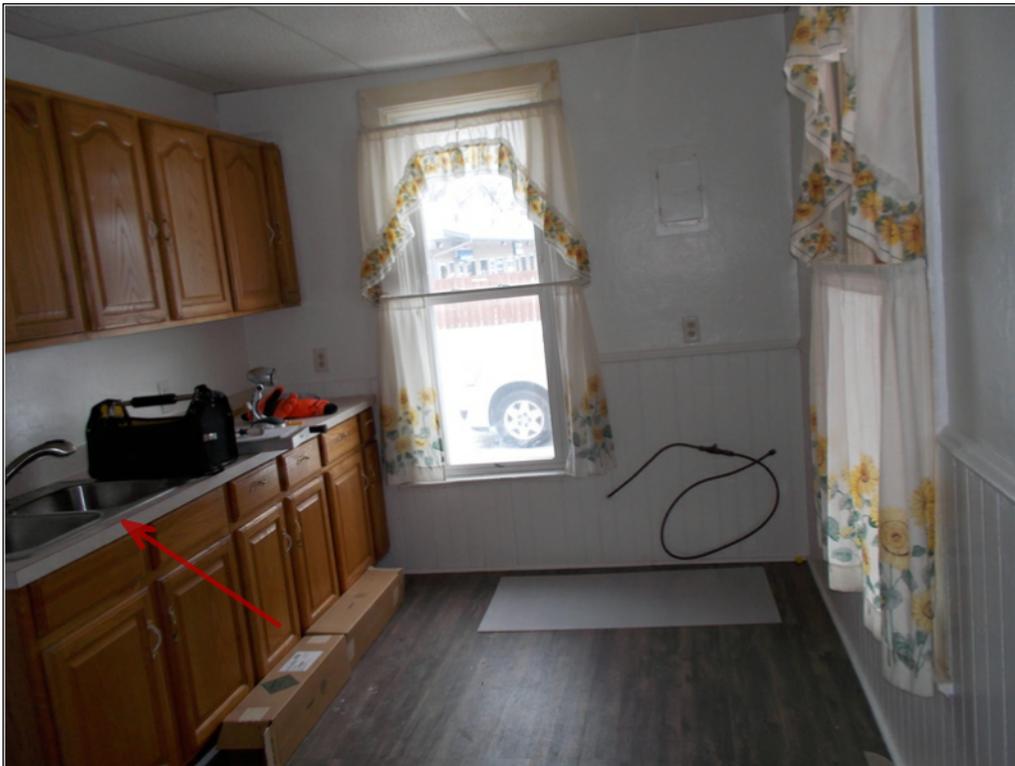
Photograph 13 - View of the kitchen sink with sound deadener, Sample07.

Sample Layers	Asbestos Content
Black Sink Undercoating	ND
Sample Composite Homogeneity:	Good
